TAKING STOCK: Opportunities and Challenges in California's Natural Gas Distribution System

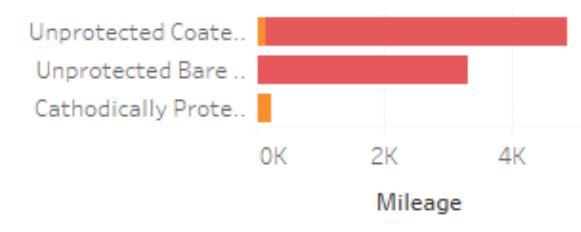
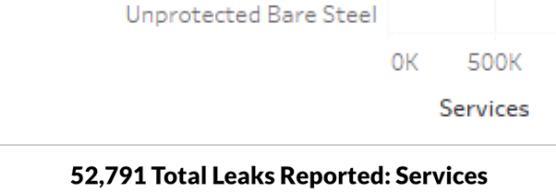
8,430 Miles of Pipeline made from Leak-Prone Materials

As of 2014, California had an estimated 8,430 miles of distribution pipelines made from leakprone materials: 3,330 miles of bare steel pipeline, 4,871 miles of coated unprotected steel, and 230 miles of cathodically protected steel^{vi}. Gas workers engaged in this project noted significant presence of older plastic pipe—which is prone to cracks and leaks—that is not well accounted for in current inventories.

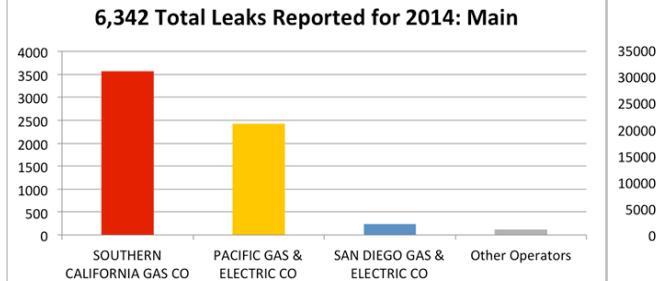
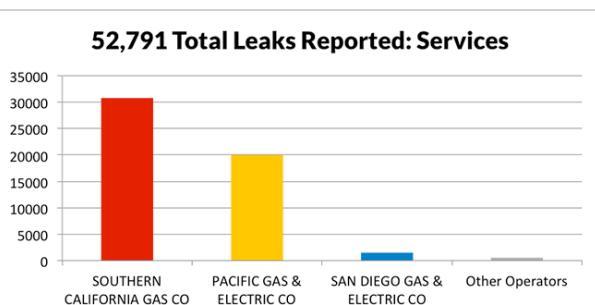
Causes of Leaks: Main

Material or Welds Other Corrosion Corrosion Excavation Damage Equipment Other Material or Welds Incorrect Operation Excavation Damage Natural Forces Incorrect Operation Equipment Other Outside Force Dam.. Other Outside Force Dam.. Natural Forces 500 1000 0K 5K 10K Leaks 🖈 📻 Leaks 🗧

Causes of Leaks: Services

Cause of Leak	Number of Leaks	Percentage
Corrosion	3135	49.4%
Material or Weld	1426	22.5%
Excavation	672	10.6%
Other	550	8.7%
Incorrect Operations	355	5.6%
Natural Forces	153	2.4%
Equipment	44	0.7%
Other Outside Force	7	0.1%
Damage		
Total	6342	100%

Causes of Natural Gas Leaks in California
